MARINE INVESTIGATION REPORT
M02W0102

CAPSIZING

SMALL FISHING VESSEL *FRITZI-ANN*
NEAR KELSEY BAY, BRITISH COLUMBIA
08 JULY 2002

Report Number M02W0102

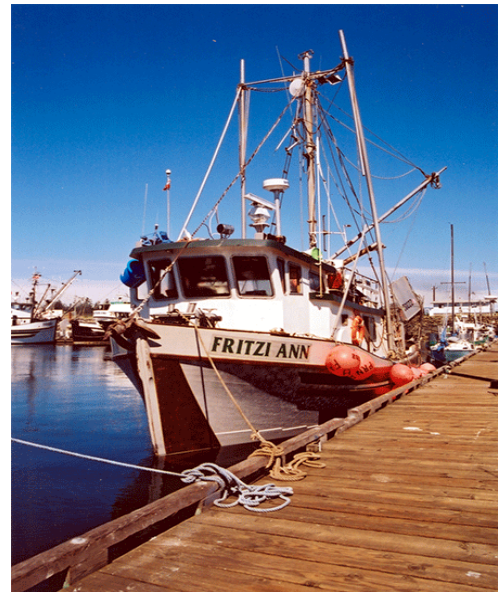
Photo 1. The *Fritzi-Ann*

The *Fritzi-Ann* is a small wooden carvel-built fishing vessel of closed construction with a rounded bilge. The wheelhouse, crew accommodation and engine-room space are located forward of midships. An insulated fish hold, a small freezer compartment and the lazaret are located aft. The fish hold is divided into six sections by portable pen boards and it has a fibreglass weathertight hatch cover.
